Cost-effective repair solutions!

The complicated design of the front axle on the Peugeot 508, 407 and Citroën C6, C5 III is susceptible to premature wear. Ball joints and knuckle bearings are affected the most often.

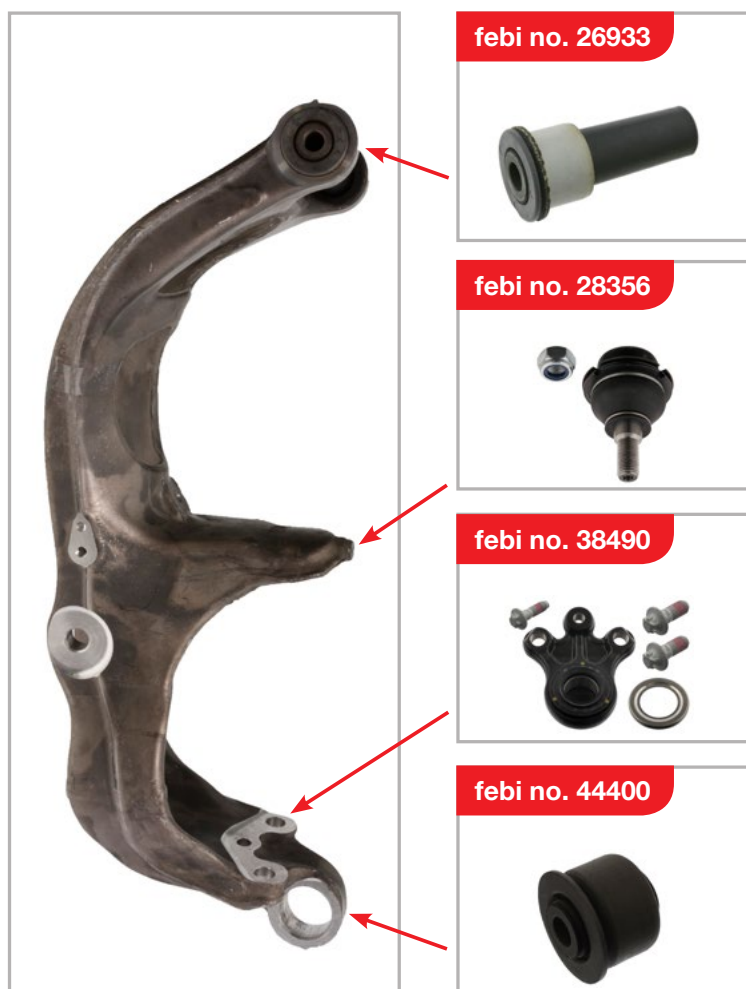
The strut assembly repair kit contains two ball joints and knuckle bearings along with all the necessary nuts and bolts. This complete kit allows for a professional repair and saves the workshop time and the customer money!
