# NEW PRODUCT HIGHLIGHT | SEP2020

## febi 105911

To Fit:  
MAN TGA

## Switchgear for Transmission

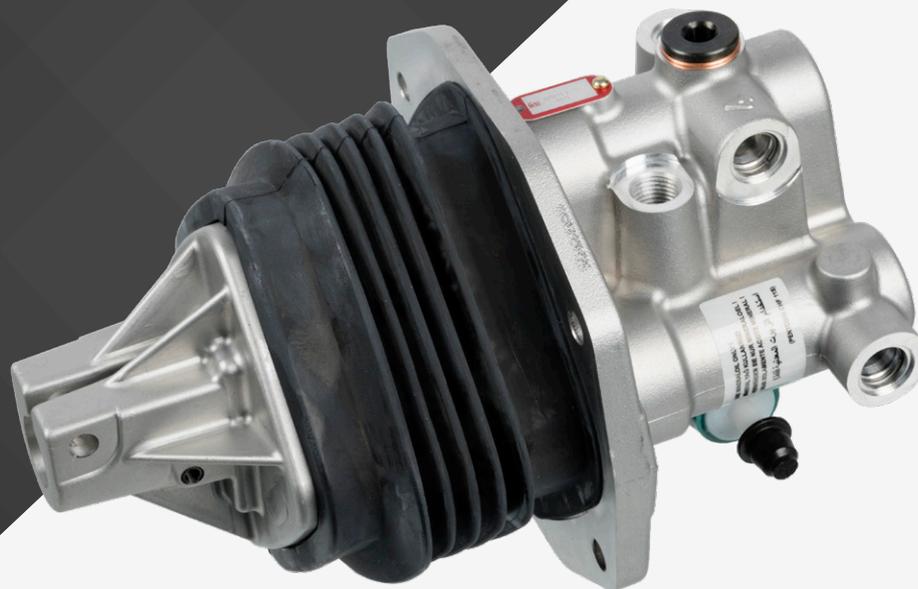
The switchgear is required to hydraulically actuate the shift valves on the transmission and thus be able to shift the gears in the transmission. It is located below the cab and the shift lever is directly connected to it. In combination with the shift valves on the transmission it forms a closed hydraulic circuit.

As the switchgear works hydraulically, only a completely vented system can fulfil its function correctly. When dismantling the transmission, for example when changing the clutch, the hydraulic circuit is often opened to separate the components. Air can then enter the circuit. If the system is not bled correctly during assembly, the system cannot function properly. In addition, if there is air in the system, the missing center position of the shift lever can cause the shift actuation to move to the left and right stops. This is where valves are located, which can be damaged. In such a case the complete switchgear unit must be replaced.
