CVJ-ENG/03-05/2019

CV BOOTS Possible causes of damage

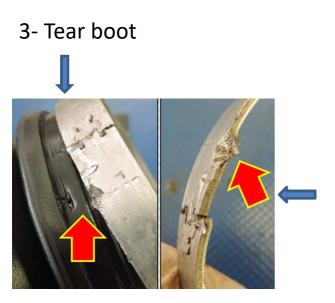
Damage

- Grease leakage
- Presence of grease under the clamp.

1- Bad clamping

2- Bad clamp or bad boot position

4- Shock on the boot clamp

The manufacturers fitting instructions and specified torque setting should always be followed. The correct tools should always be used for the removal and fitment process.
